FIRMWARE VERSION: 2.3.4 S
DATE: November 18, 2022

THIS IS A RECOMMENDED UPDATE

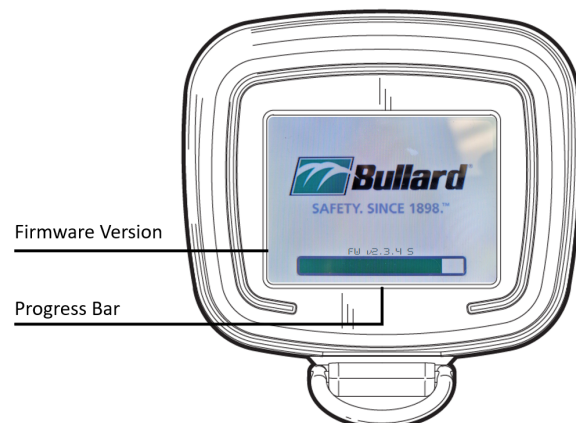
FIGURE 3

Power on the camera and identify the firmware version shown above the progress bar as in Figure 3 above. If this is 2.3.2S or earlier, then please update the firmware

1. Download firmware 2.3.4 S from website onto PC and unzip onto local hard drive.
2. Push the power button to turn the camera on. Wait for camera to completely boot. (Loading screen will change to a live image)
3. Connect the micro USB cable to the USB port under the protective cap as shown in **FIGURE 1**
4. The “TXS (D:)” drive should open automatically.
5. Drag the new firmware file “fw234-secure.swu” into camera’s Update folder as shown in **FIGURE 2**
6. File will load to 100%
7. Eject the camera from the USB device manager.
8. Unplug the USB cable from camera
9. Push power button to turn camera back on and allow software to update. Screen may flash several times and turn blue during update. Update should take no longer than 2 minutes.
10. After software installation is complete, verify that the screen is showing firmware version 2.3.4S above the progress bar. (See **FIGURE 3**)
